Arboricultural Assessment For Proposed Access Road

Park Village Residential Development

32 Middleton Street Highett

July 2021

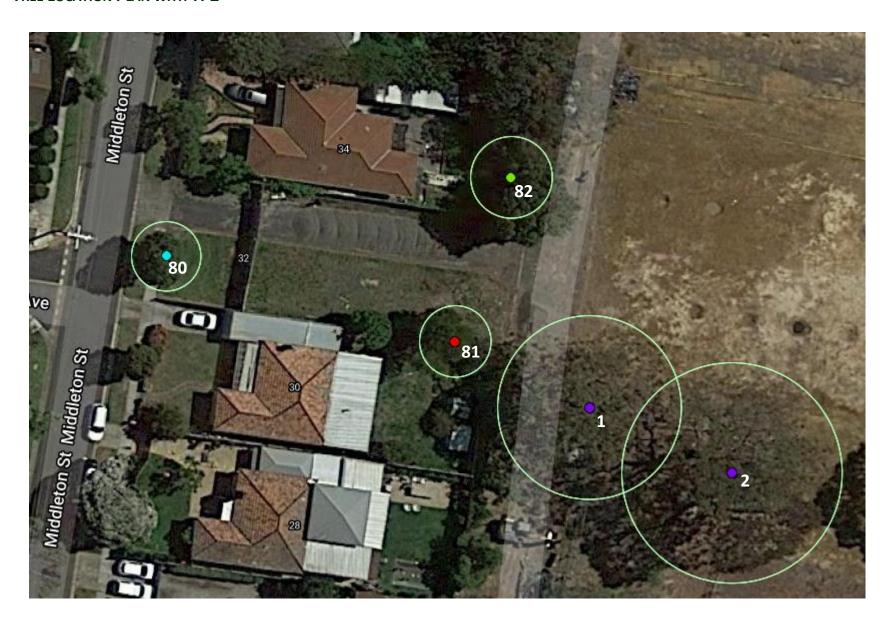
7 TREE LOCATION PLAN WITH TPZ

- 3.2 Tree number 80, *Lophostemon confertus* (Queensland Brush Box) is located within the road reserve at the front of the site. The tree is in a fair overall condition and is a semi-mature specimen.

- 3.3.1 Tree number 81, Acacia melanoxylon (Blackwood) is has been poorly pruned; all foliage on the southern side of the tree has been removed (lopped) and the tree is hard up against the boundary fence. The tree will impact on the fence as the tree matures in the near future if retained. Given the poor structure of the tree, the past lopping of the tree and the likely impact with the boundary fence the tree is considered to have a life expectancy of less than 5 years and is considered to attain a low arboricultural rating.

- 3.4.1 Tree number 82, *Syzygium smithii* (Lilly Pilly) is in a fair overall condition and considered to attain a medium arboricultural value and the tree should be retained and protected. The proposed access road is located approximately 2.6 metres from the southern boundary fence and the tree is located approximately 1.9 metres north of the boundary fence, resulting in the distance from the tree's centre to the closest edge of the footpath being approximately 4.5 metres from tree centre.

- 3.5.1 Tree number 1, *Eucalyptus melliodora* (Yellow Box) is considered to be a significant tree in a fair overall condition. The proposed access road is located outside the tree's canopy. Given the significance of this tree if possible, the access road and footpath should be located outside the protection zone of 10.8 metres from tree centre.

3.5.2 Tree number 2, *Eucalyptus melliodora* (Yellow Box) is considered to be a significant tree in a fair overall condition. The proposed access road is located outside the tree's canopy and tree protection zone of 12.9 metres from tree centre.

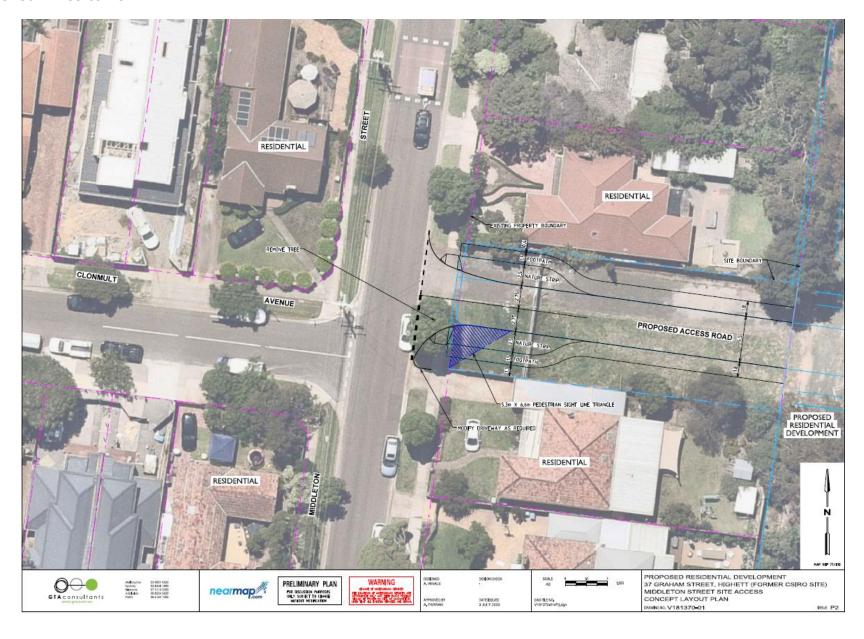
8 Proposed Access Road

- 3.2.1 Tree number 80, Lophostemon confertus (Queensland Brush Box) is situated in the location of the proposed crossover to the site. The tree cannot be retained in conjunction with the construction of the proposed access road.

- 4.2.1 The proposed access road and footpath to the north of tree number 81, *Acacia melanoxylon* (Blackwood) will be 3.5 metres from tree centre. AS 4970-2009 Protection of Trees on Development Sites states that an encroachment of up to 10% of the tree protection area is considered minor and this equates to 2.9 metres from tree centre for this tree. Therefore the proposed access road and footpath will be 3.5 metres to the north of tree and considered a minor encroachment only.

- 4.3.1 The proposed access road and footpath to the south of tree number 82, *Syzygium smithii* (Lilly Pilly) will be 4.4 metres from tree centre. AS 4970-2009 Protection of Trees on Development Sites states that an encroachment of up to 10% of the tree protection area is considered minor and this equates to 3.3 metres from tree centre for this tree. Therefore the proposed access road and footpath will be 4.4 metres to the south of tree and considered a minor encroachment only.

4.4.2 For tree number 1, *Eucalyptus melliodora* (Yellow Box), should the proposed access road and footpath come within the 10.8 tree protection zone then the proposed access road and footpath should be located on or above grade with no excavation and be no closer than the PTZ 10% of 7.4 metres.

4.4.3 The proposed access road north of tree number 2, *Eucalyptus melliodora* (Yellow Box) is located outside the tree's canopy and tree protection zone of 12.9 metres from tree centre. No construction impact from the access road and footpath construction would be expected.

- 4.2.2 The area between the proposed access road and footpath to the north of tree number 81, *Acacia melanoxylon* (Blackwood) will require protection and this should be discussed within a specific site Tree Management Plan.

- 4.3.2 The area between the proposed access road and footpath to the north of tree number 82, Syzygium smithii (Lilly Pilly) will require protection and this should be discussed within a specific site Tree Management Plan.
